Manhole Inspection Summary

Manhole # S13AA2010MH

Insp Date: **7/25/06 1:23 PM**

Location Address: **2208 SOUTH RD**

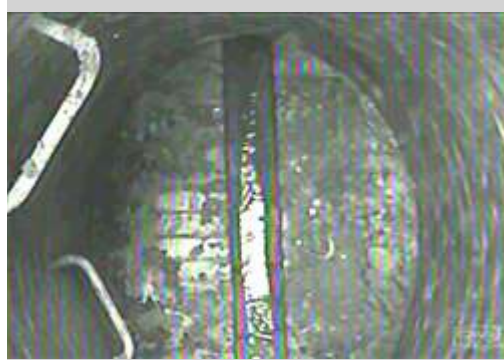
Top View

Evidence of surcharge - Bench debris.

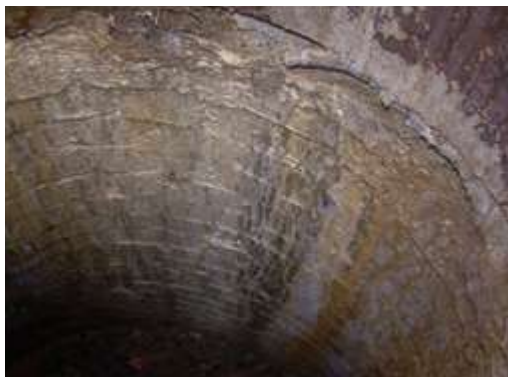
Defect

Adjustment infiltration - other side.

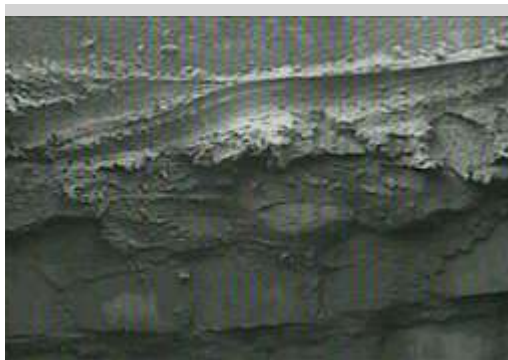
Defect

Frame leaks. Adjustment infiltration.
Adjustment parging.

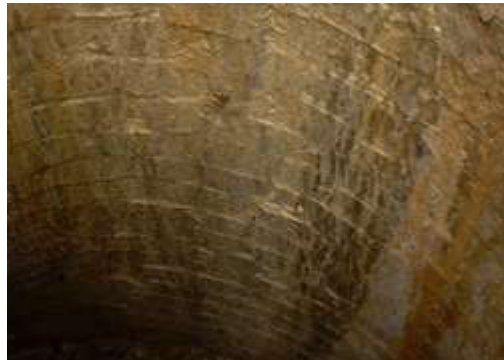
Defect

Adjustment infiltration.

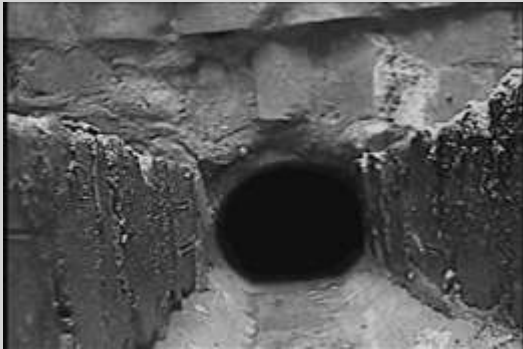
6 in. Circular Gravity Sewer Pipe Out @ 12 O'Clock

Barrel deterioration and infiltration. Channel deterioration.

Infiltration: **Evidence** Pipe Seal Cond: **Unknown**

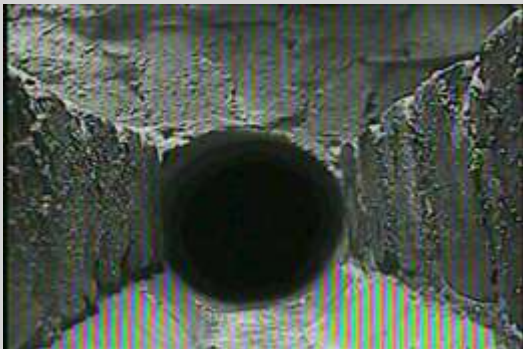
6 in. Circular Gravity Sewer Pipe In @ 6 O'Clock

Channel deterioration.

Infiltration: **None** Pipe Seal Cond: **Cracked**
